AT TAHOE'S HIGHWAY 50
**Slopes stabilized,
erosion halted**

Geosynthetic reinforcement solutions for Lake Tahoe highway

By Katie Westfall

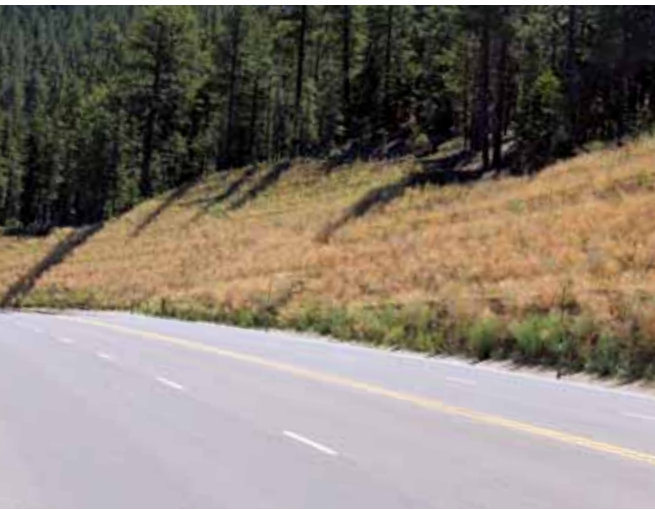
The slope along U.S. 50 near Lake Tahoe is now secure and stable. The project's life is expected to be in excess of 70 years.

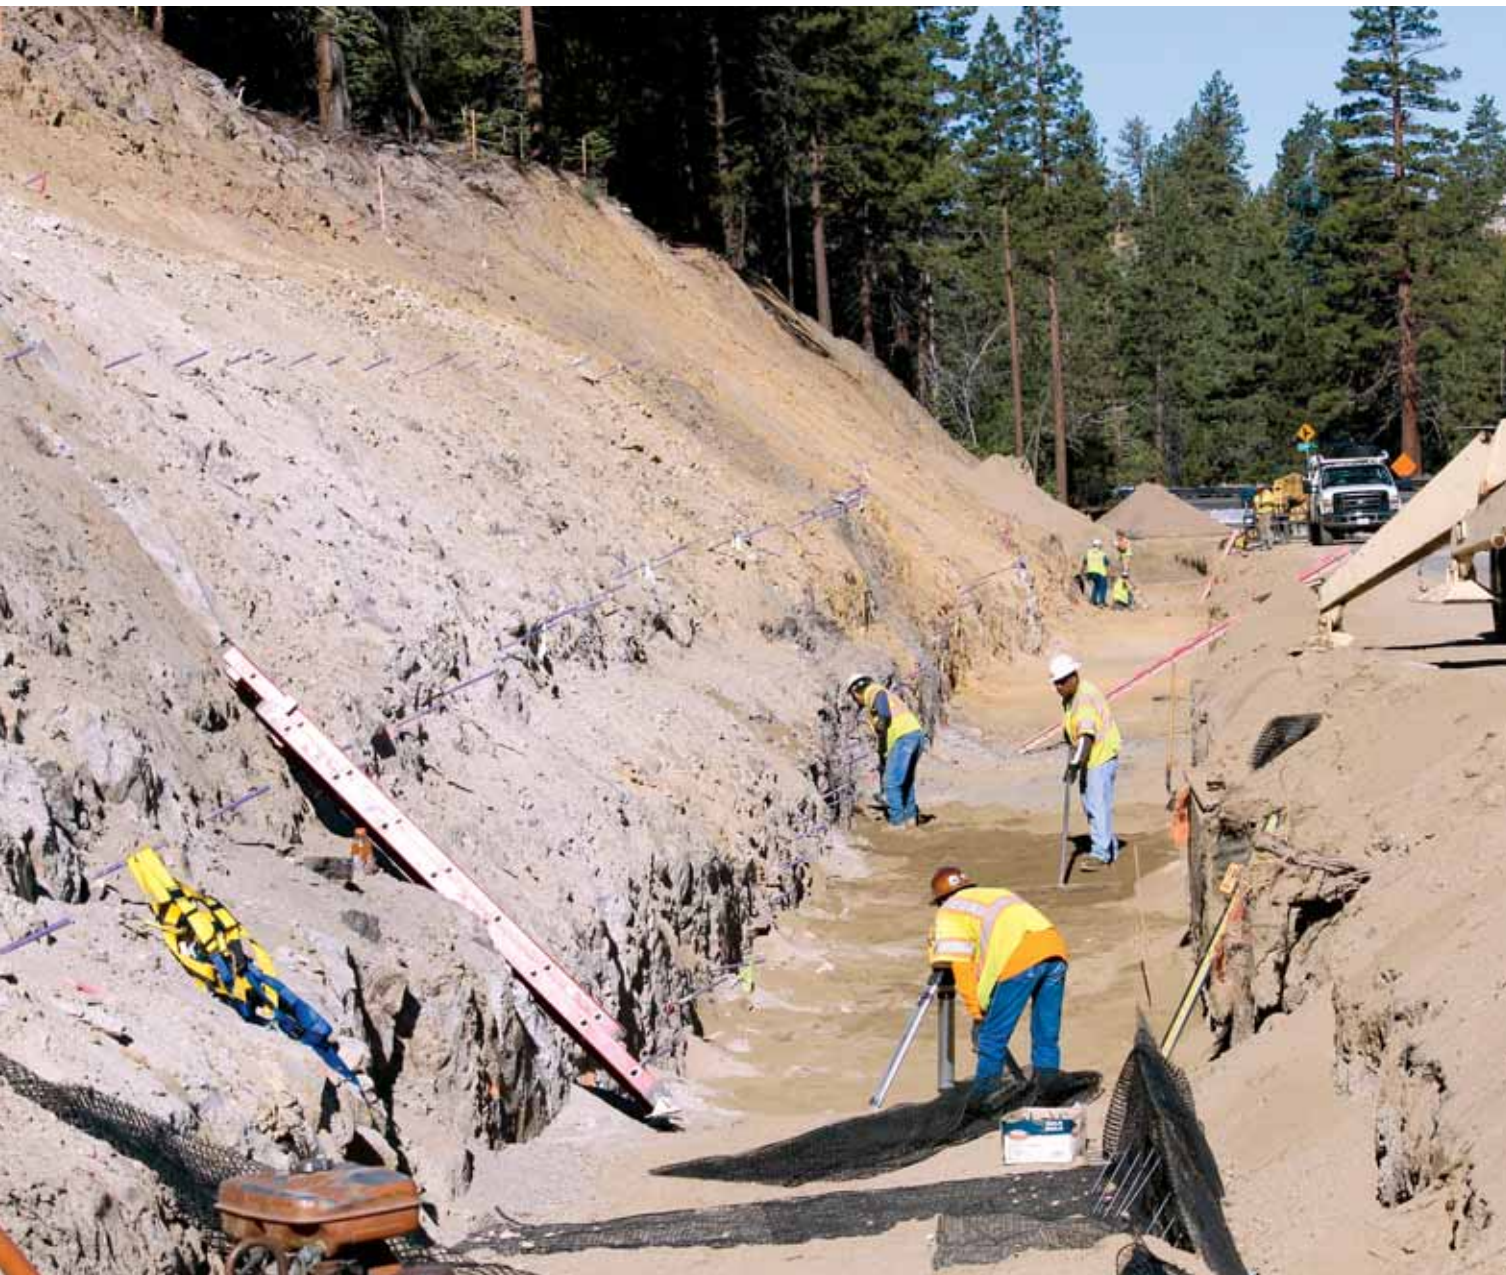
PHOTO 1 Rock anchor drilling commenced in the spring of 2012. Rock anchors were the linchpins of the project and their design was carefully considered to withstand the loads on the veneer soil slope.

Underground utilities construction began in spring 2011, but it wasn't until spring 2012 that slope construction got under way (**Photo 1**). Completion of the U.S. 50 slope reinforcement project was hampered by problematic soil conditions in one area of the slope and work slowed during the summer tourist season

Drilling the holes for each rock anchor began after site preparation. The rock anchors were the linchpins of the project and their design was carefully considered to withstand the anchor loads and the forces of gravity at play on the slope face.

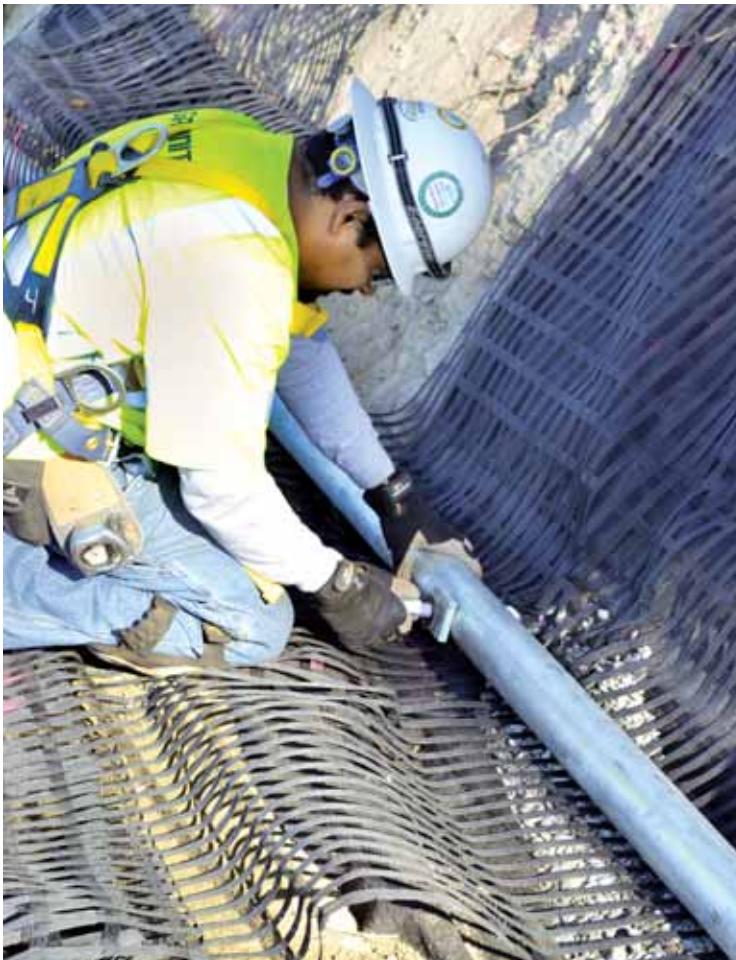
PHOTO 2 At each anchor location, a 6-foot-wide layer of geogrid was attached using a simple wrap connection around 3-inch diameter pipe.

spacing. Where the bar exited the bedrock it was fastened to the center of a 7-ft galvanized steel pipe positioned horizontal against the granite face. At each anchor location, a 6ft-wide layer of geogrid was attached using a simple geogrid wrap connection (**Photo 2**). The geogrid extended to the welded wire form facing (approximately 9ft or more from the anchor) where it was also placed in wrap configuration behind the wire forms. The geogrid wrap and rock anchor T-bar system provided a stable connection between the welded wire form facing and excavated slope face. (**Figure 1** illustrates a typical geogrid rock anchor.)

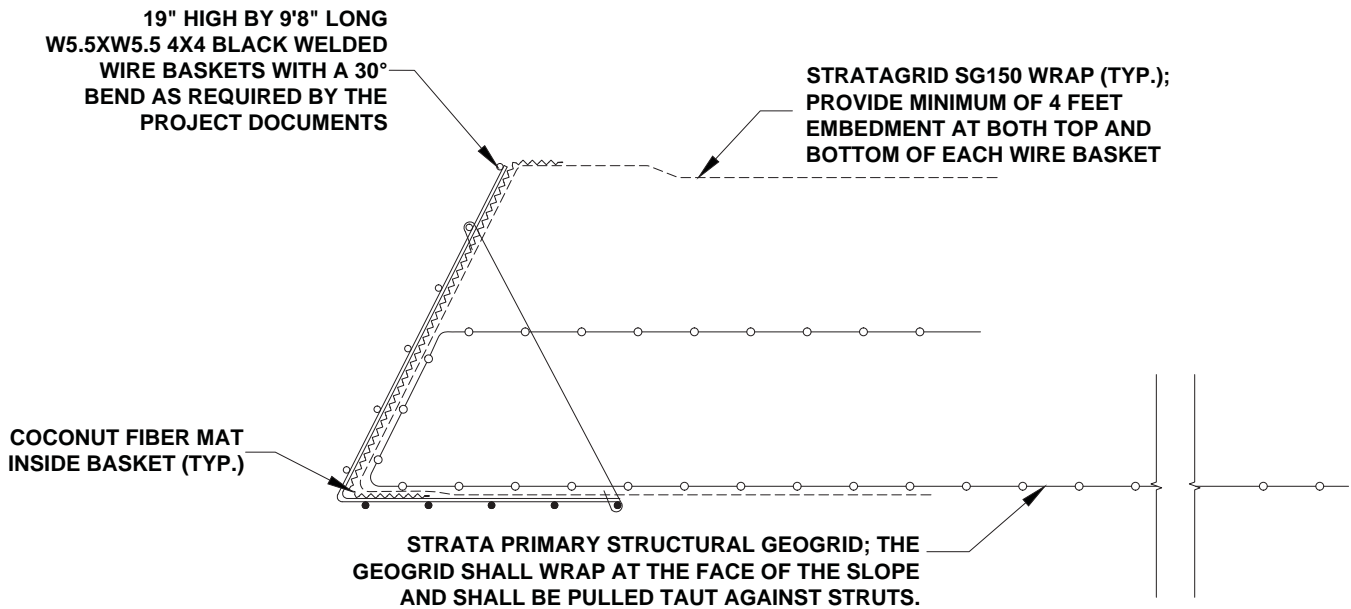
FIGURE 2

6 WELDED WIRE BASKET, COCONUT AND GEOGRID PLACEMENT DETAIL

standards. For this project, forms were fabricated in conformance with ASTM A185 with w5.5 steel wire meeting ASTM A82.) The resulting welded wire forms measured about 10ft long and 22in. x 18 in. with a 4in. x 4in. aperture. The welded wire forms were constructed off-site by cold bending wire fabric to a 60-degree batter (from horizontal) with a vertical face height of 19in. (Figure 2 illustrates typical facing detail.)

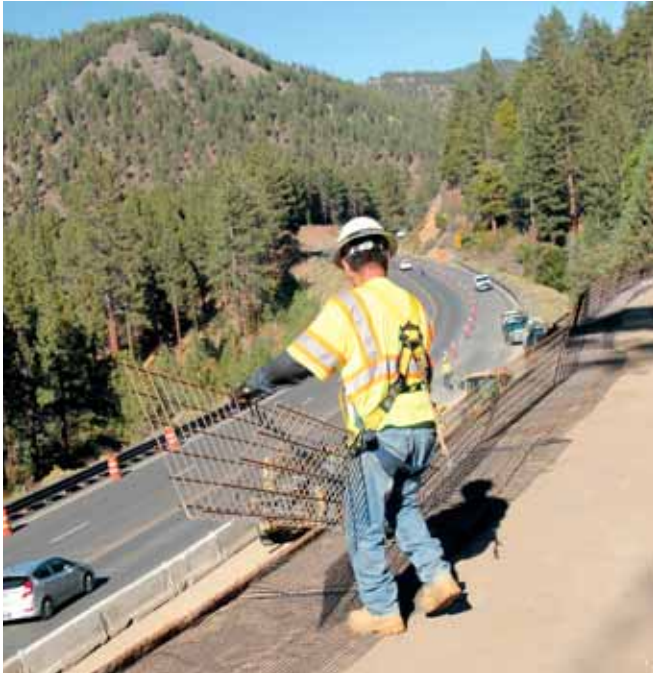
PHOTO 3 The welded wire forms were fabricated in conformance with ASTM A185 with w5.5 steel wire meeting ASTM A82 and measured about 10 feet long with a 22-inch front face (19-inch vertical rise) and an 18-inch base.

Backfill was placed and compacted at the toe of the slope prior to construction of the first micro-terrace, which began at the bottom of Slope 21 and continued upward. The WWFs were placed along the horizontal length of the slope and vertical joints were staggered (Photo 3). Adjacent WWFs were tied together using hog rings. This strong yet flexible system allows for some movement and can tolerate a certain amount of settlement.

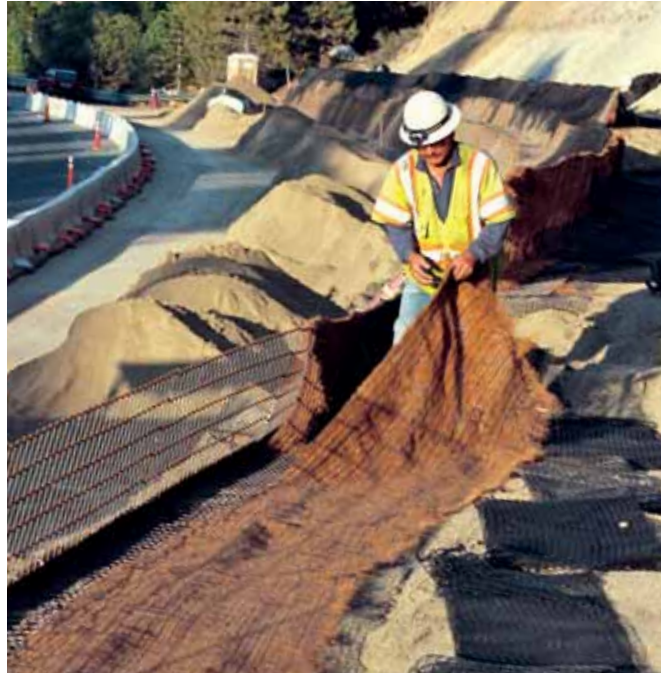
PHOTO 4 As baskets were placed, each was wrapped in a biodegradable coconut blanket to control erosion and stabilize the soil while local vegetation was established on the micro-terraces. The blankets were seeded by hand on the slope-facing side of the blanket.

As baskets were placed, each was wrapped in a biodegradable coconut blanket to control erosion and stabilize the soil while vegetation was established on the micro-terraces. Four stakes per square yard in an offset square pattern held the coconut blanket in place.

The secondary reinforcement face wrap had a minimum embedment of 4ft at the top and bottom of each basket (Photo 4). Micro-terraces were backfilled as they were built from the ground up (Photos 5, 6, and 7).

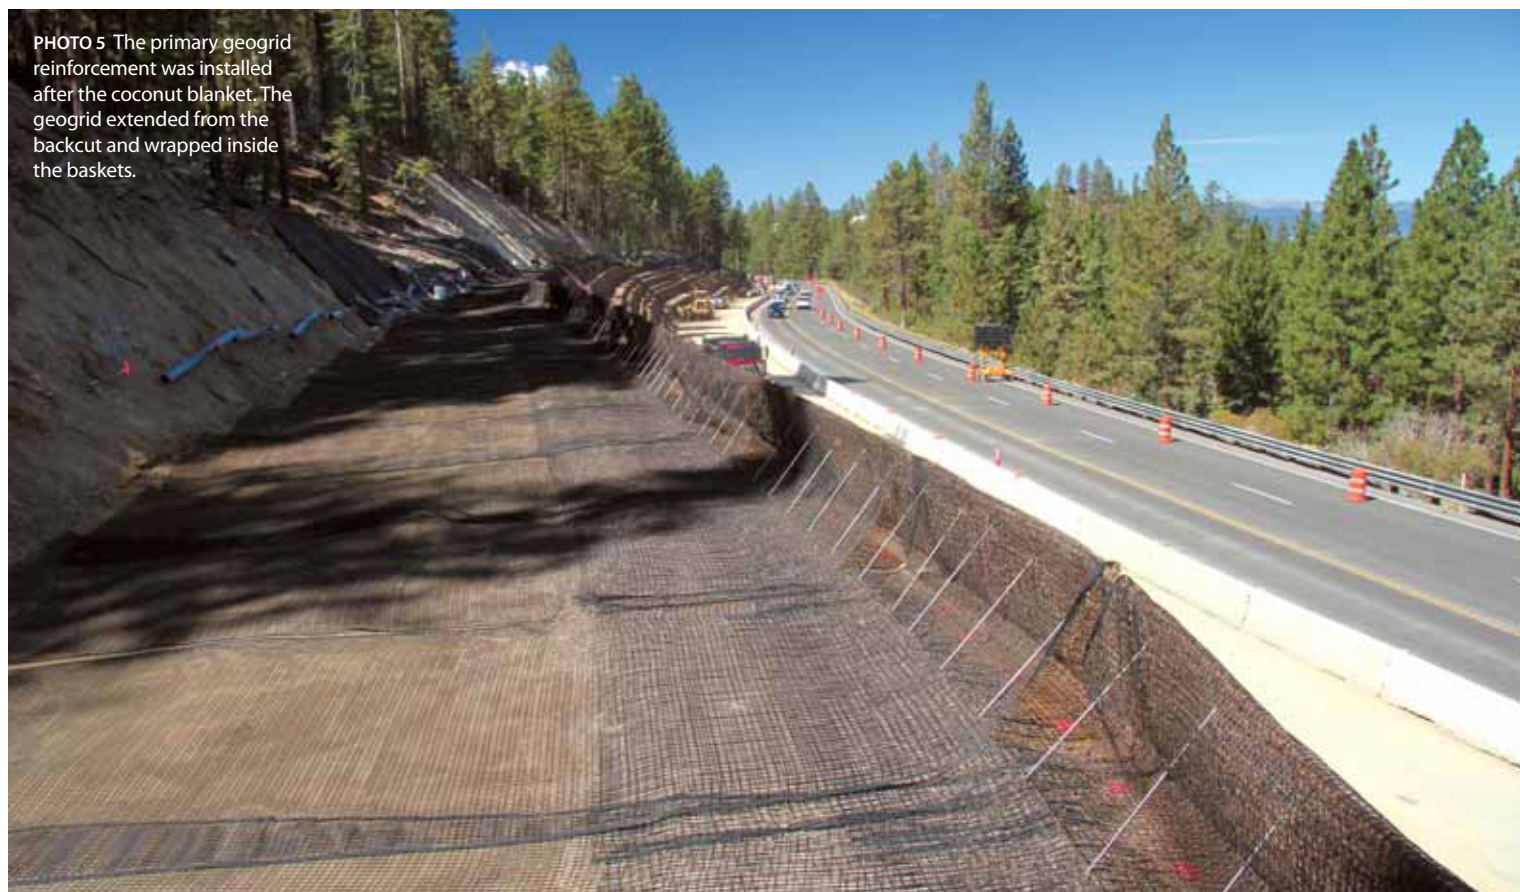
PHOTO 5 The primary geogrid reinforcement was installed after the coconut blanket. The geogrid extended from the backcut and wrapped inside the baskets.

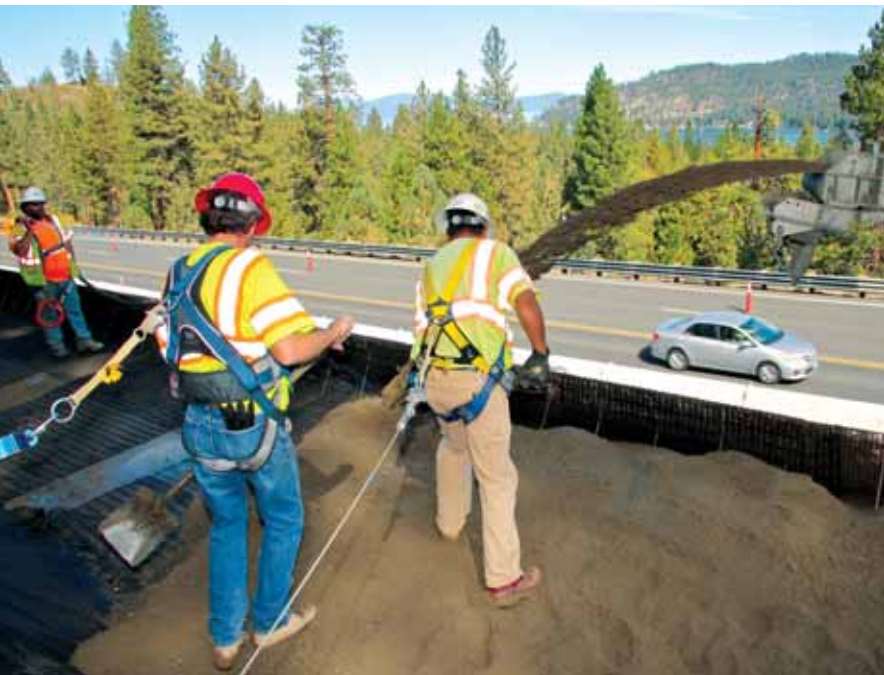
PHOTO 6 Backfill was placed using a portable conveyer to reach the higher elevations of the slope.

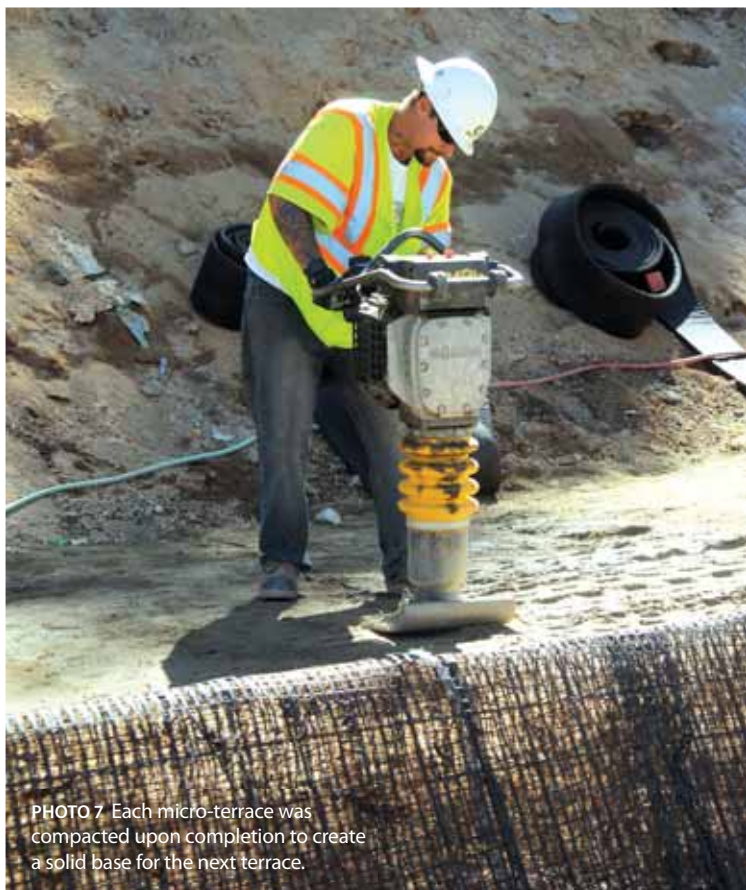
PHOTO 7 Each micro-terrace was compacted upon completion to create a solid base for the next terrace.

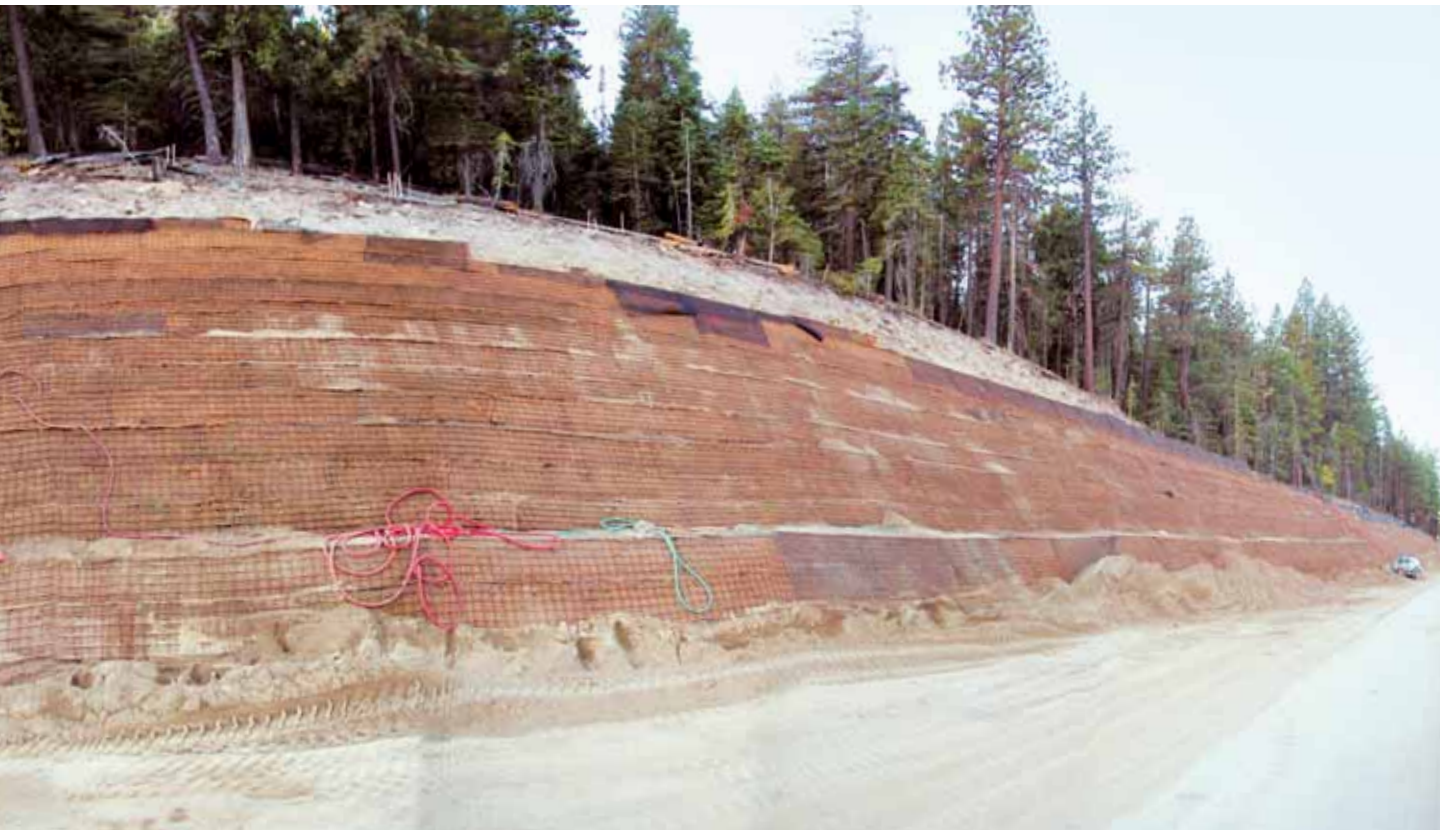
PHOTO 8 A wide-view lens captures the entire slope near project completion. This reinforced soil slope meets requirements for beauty and strength: Motorists are protected from rocks and soil in the road, and runoff has been stopped from crossing under the roadway and emptying into a nearby stream system that flows into Lake Tahoe.

winter. From October to mid-December 2012, the crews worked on slopes 27 East and 27 West, finishing the construction in mid-December (Photo 8).
